ATLANTIC CROSSING ~ IT COULD HAVE BEEN EASIER

Martin Grube

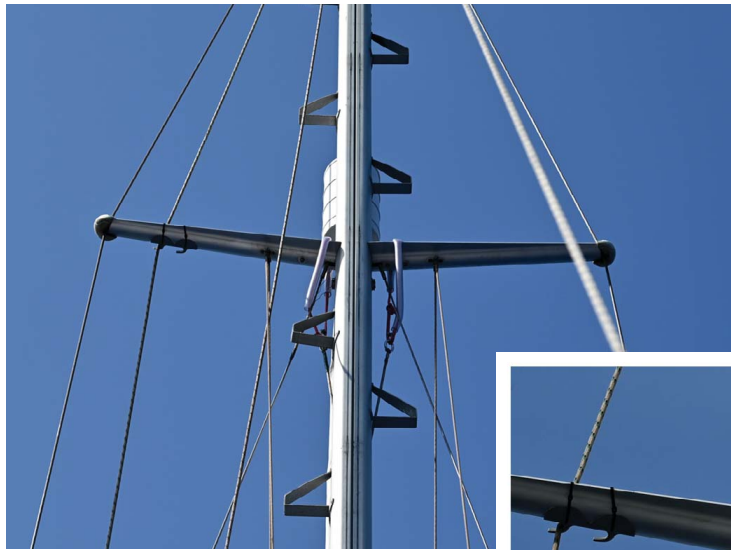
*In the end we
got our running
backstays fixed
correctly*

As we tried to tighten our construction we noticed that I had twisted the running backstays at the lower spreaders, so I had to climb up that far again. As I wrote earlier, if you are clinging to the mast and being tossed around badly your head does not work properly. Then we realised that when I had attached the running backstays around the root of the top spreaders I had fixed them outside and not inside the shroud terminals, so the pressure was now on the terminals. So I had to climb up a third time. Normally we drink no alcohol while we are sailing, but afterwards Astrid gave me a glass of red wine. The main task was done and the only thing left was to reach Martinique – 1320 miles to go!

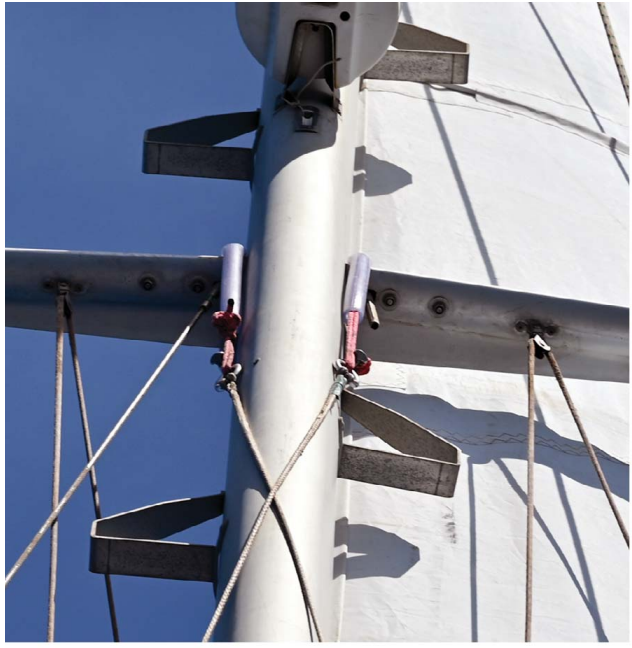
Completely broken

On the 13th day the shroud broke completely and came down. We had already made another 650 miles towards Martinique but there were still 650 miles to go. With the shroud broken completely, the mast showed a clear bend to starboard and started to work in the

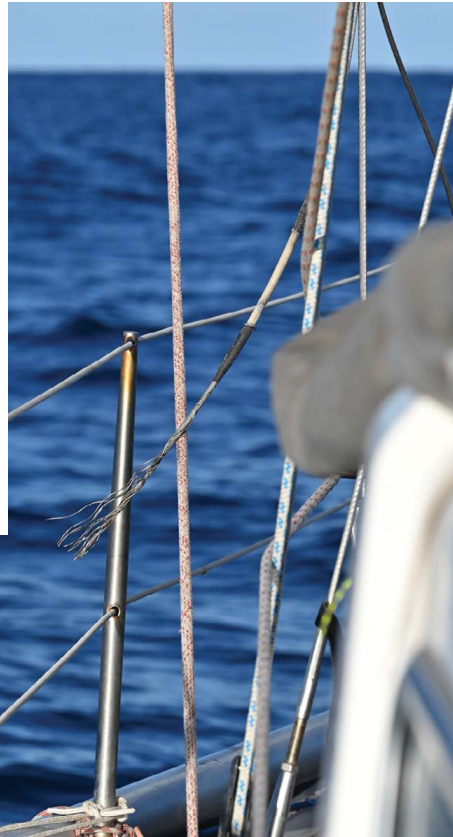
*Anti-chafe covering on
the temporary replacement*

waves even more than before. Because of this the port side running backstay began to chafe against one of the mast steps, so I climbed up again to put a piece of hose over it.
